Bat Survey: 133-135 Commercial Street, Newport, NP20 1LY

Reported by: Ecological Services Ltd
10 Mount Pleasant, Llanelly Hill, Abergavenny, Monmouth NP7 0NT

Author	Date	Version
Rich Watkins	October 2025	V2.0

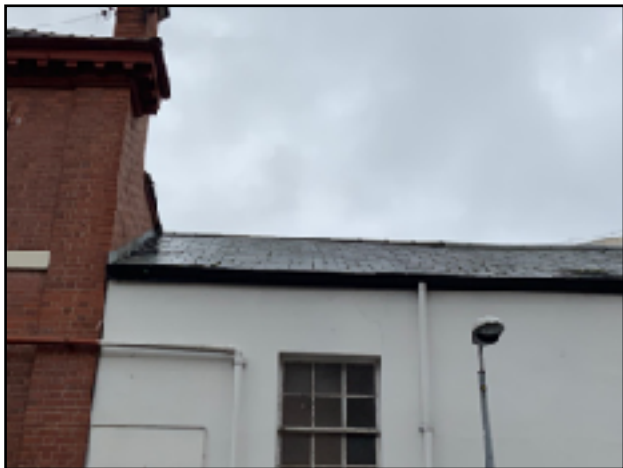
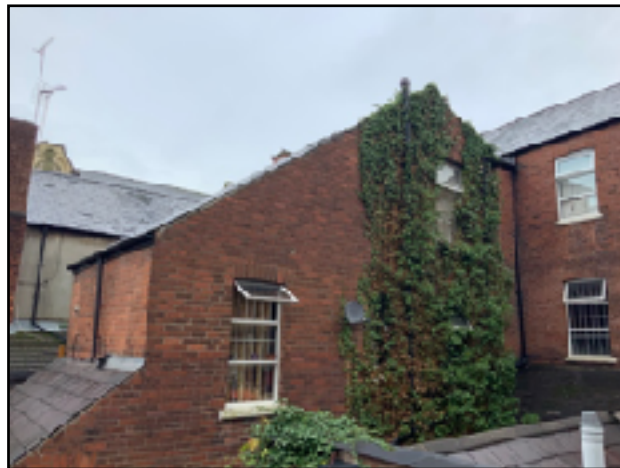
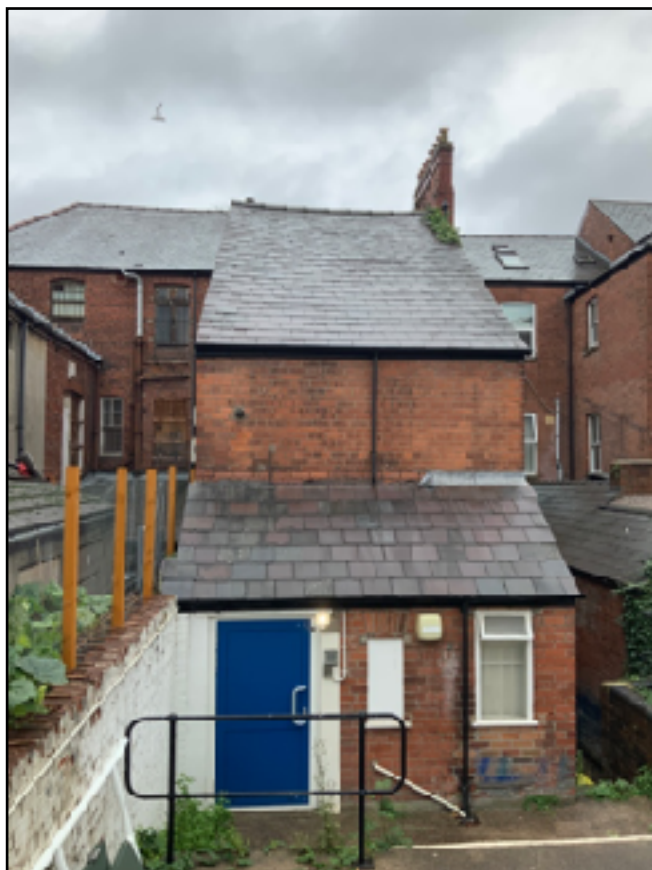
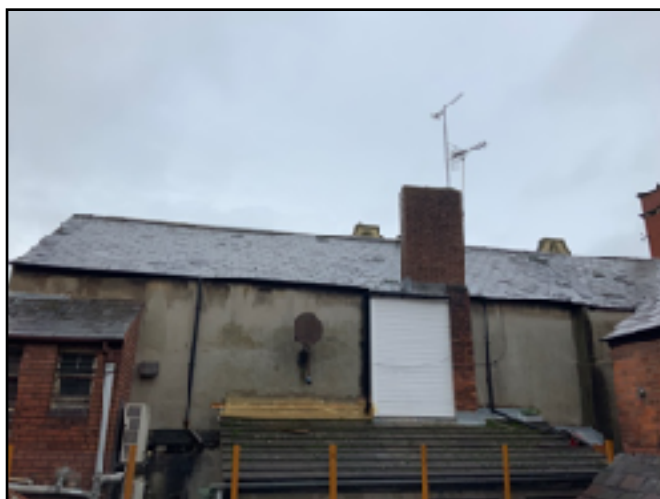
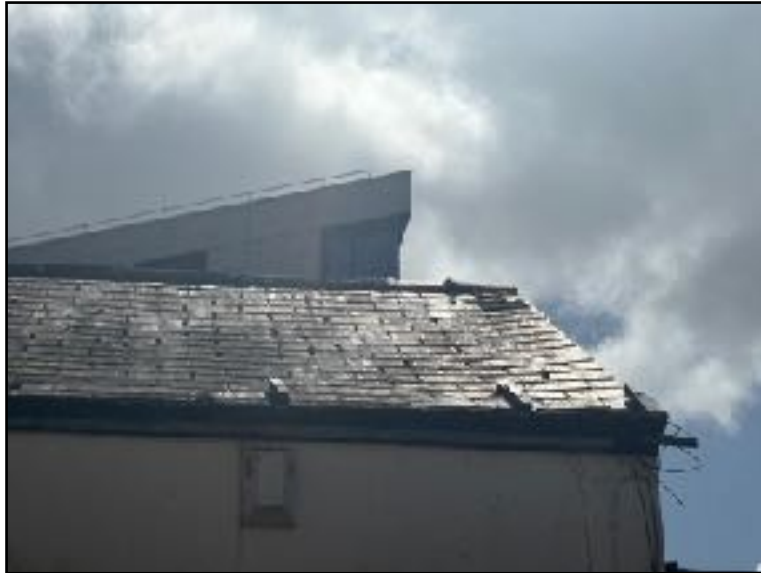
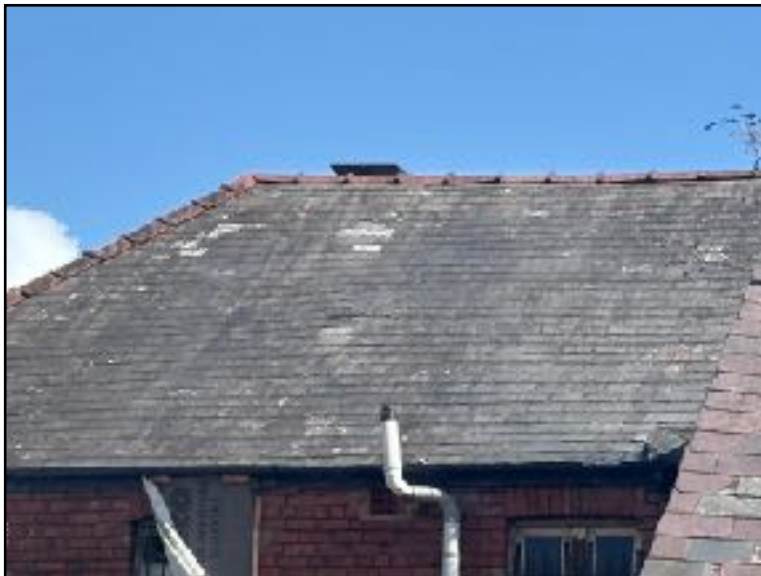
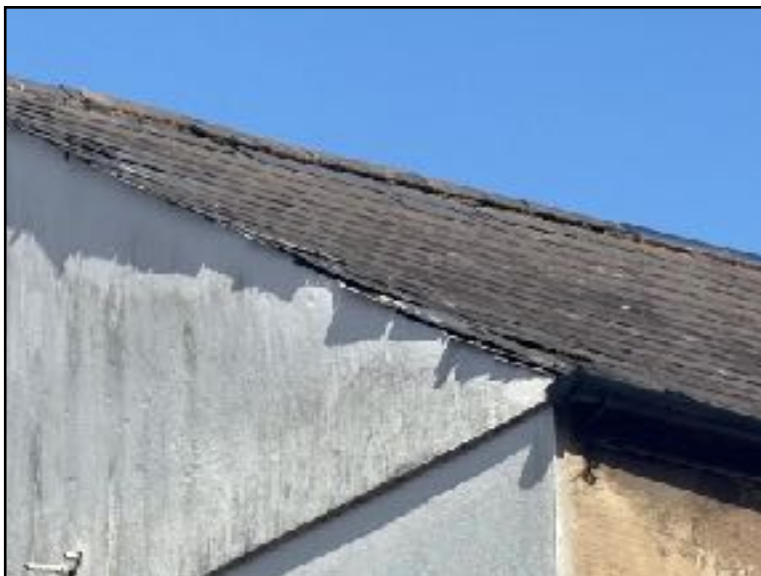
6.3 Due to the age and condition of the building, there were a small number of opportunities present for bats to access and use the building and those that were available were deemed as having moderate potential for roosting bats. There were apertures in the roof-line; raised ridge tiles and slipped slates. There was a light ivy covering on the rear extension but this was not dense enough to house a roosting bat.

6.6 Examples of apertures allowing access to cavities in the building:

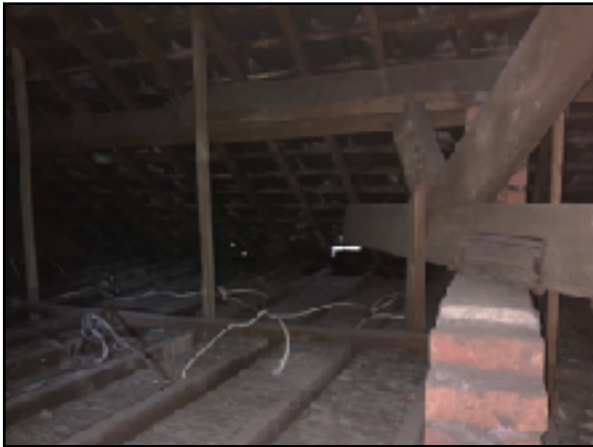
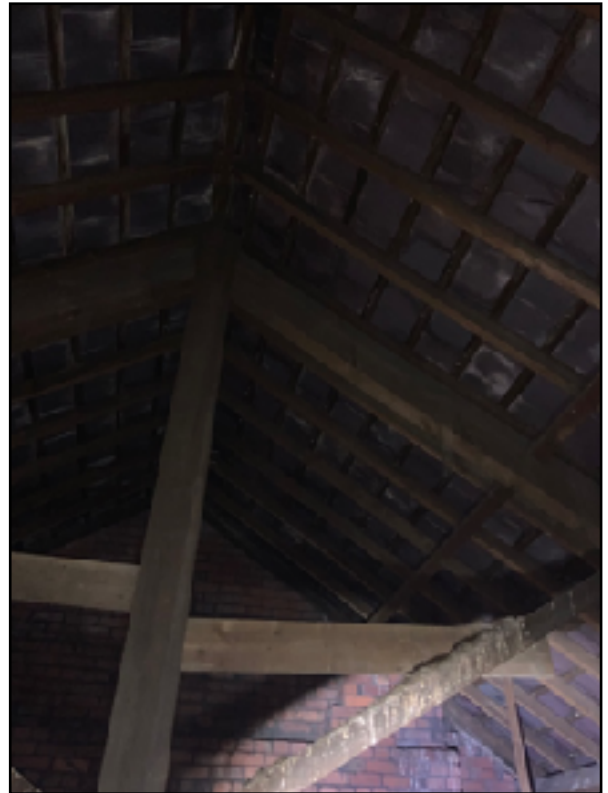
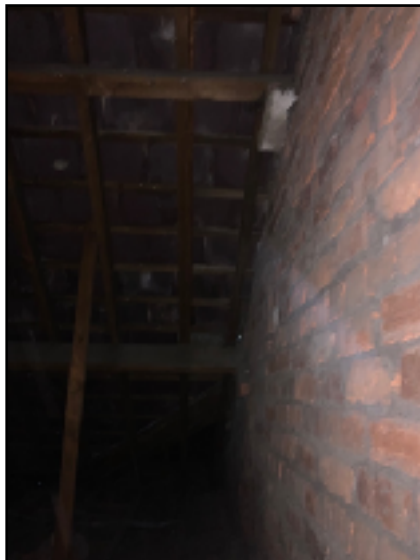
7.2 There was an attic space within the property which was enclosed; unlined and of a trussed design. Small areas of light ingress were observed within the space.

7.3 No Brown Long Eared Bats (*Plecotus auritus*) or other species of bats were observed on the visible roof timbers of the building and no night feeding perches were identified.

7.4 No bat droppings or evidence of bats were identified during the internal scoping survey.

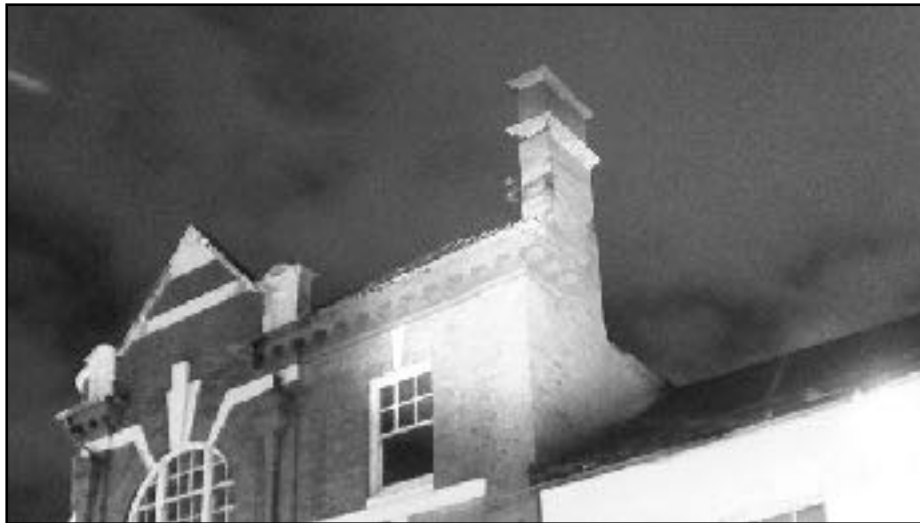
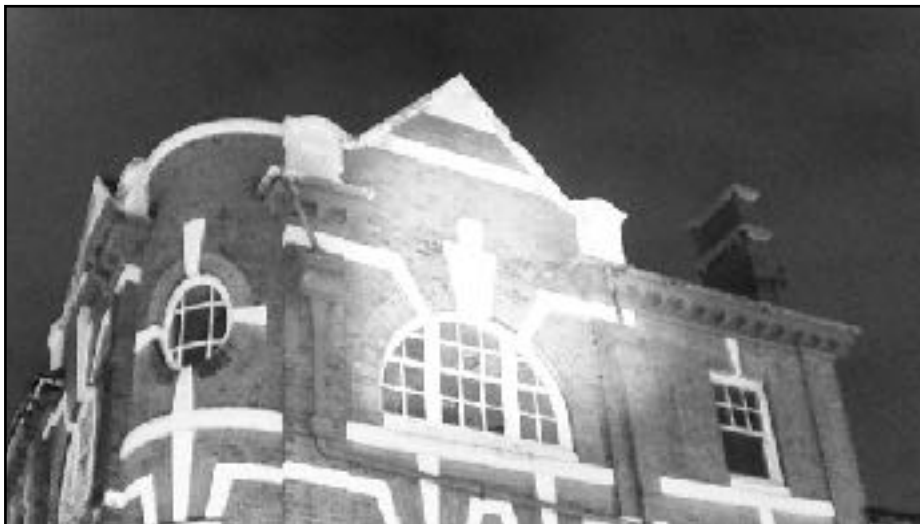
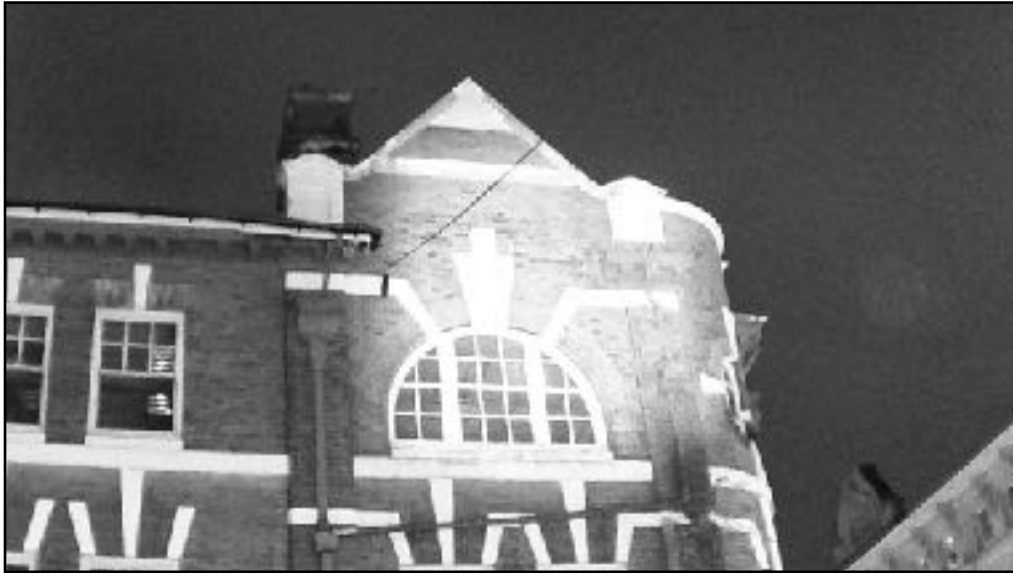
8.10 During the **28th August 2025** emergence survey, no bats were detected or observed.

8.11 During the **18th September 2025** emergence survey, only a single Noctule bat call was detected but the bat was not observed.

8.12 Examples of NVA Still Shots:

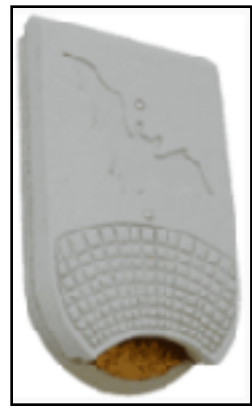
10.2 It is proposed that new roosting for bats be created by fitting one Schwegler 1FQ surface mounted bat box on the building. **The exact location will be decided by a suitably qualified ecologist.**

10.3 Bat enhancements will benefit from the southern elevation or an elevation where there is direct access to sunlight as the bats can tolerate and prefer high levels of temperature in their roost.

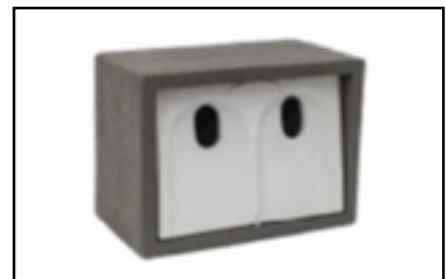
10.4 One Vivara Pro WoodStone House Sparrow Nest Box will be surface mounted on the building. **This will not be situated on a south facing elevation. The exact location will be decided by a suitably qualified ecologist.**

10.5 Any nesting bird enhancements will not be suited on the south elevation as this may experience excess heat from the sun.

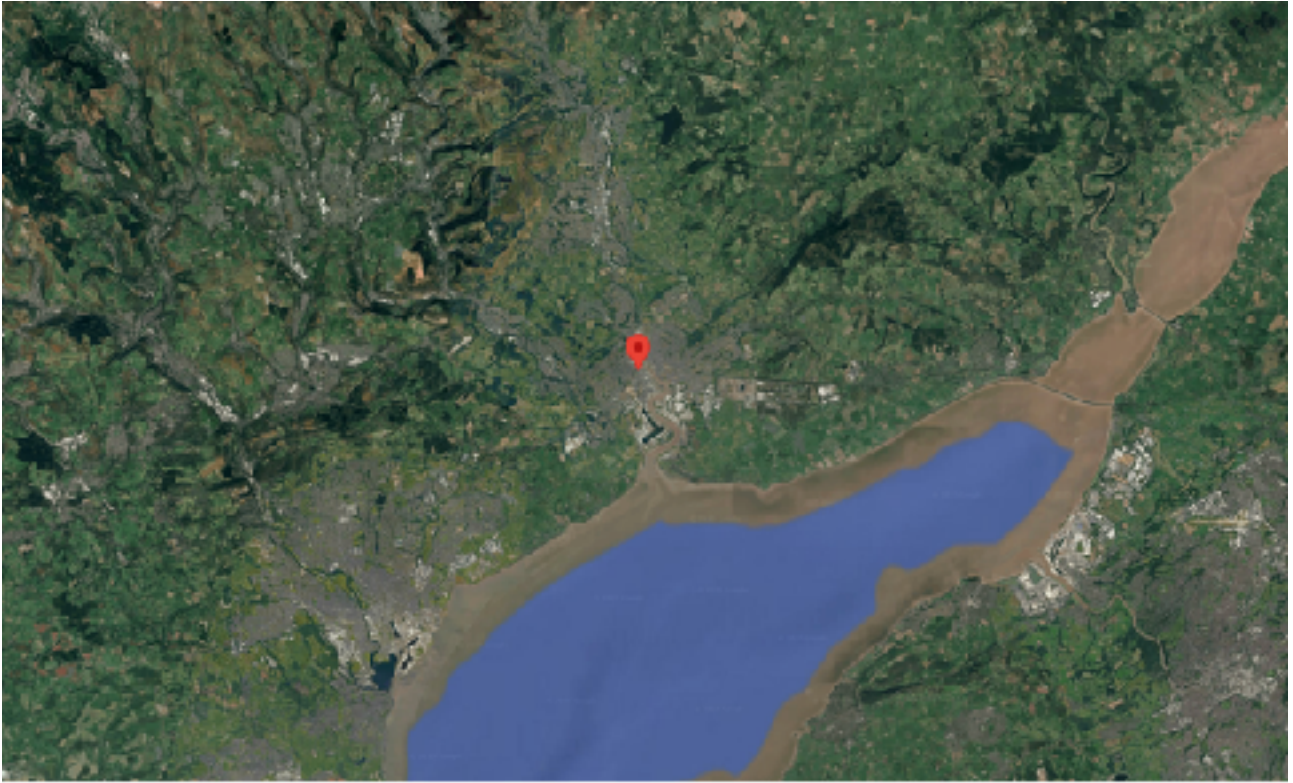
Appendix 1 Aerial Site Photograph

The site in its wider environment offering poor ecological connectivity to the surrounding habitat.
